Speed and Cut Through Traffic Analysis Oak Forest Drive The Villages District 3

Sumter County, Florida

Final Report

June 2008

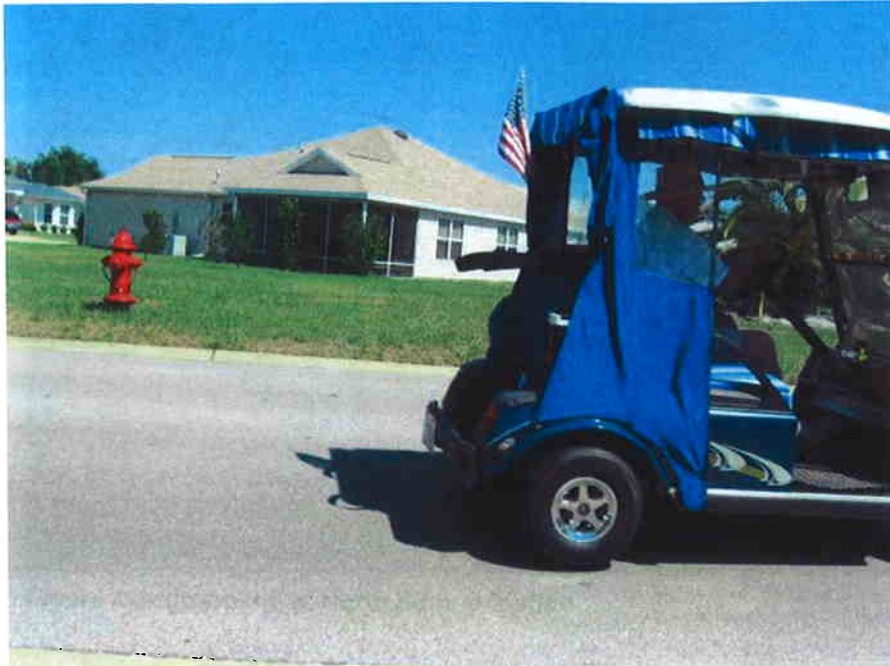
Figure 2 Northbound at South Survey Station

The photographs taken at the north survey station were compared to the photographs taken at the south survey station to identify vehicles that traveled through both survey stations. The vehicles that traveled through both survey stations are the vehicles that are using Oak Forest Boulevard as a cut-through route. A sample of the comparison photos are shown in Figures 2 through 5.

The results of the photo comparison indicated that 114 vehicles northbound and 114 vehicles southbound during the study period were utilizing Oak Forest Boulevard as a cut-through route which equates to approximately 60% of the traffic on Oak Forest Boulevard is cut-through traffic.
