Speed and Cut Through Traffic Analysis Oak Forest Drive The Villages District 3

Sumter County, Florida

Final Report

June 2008

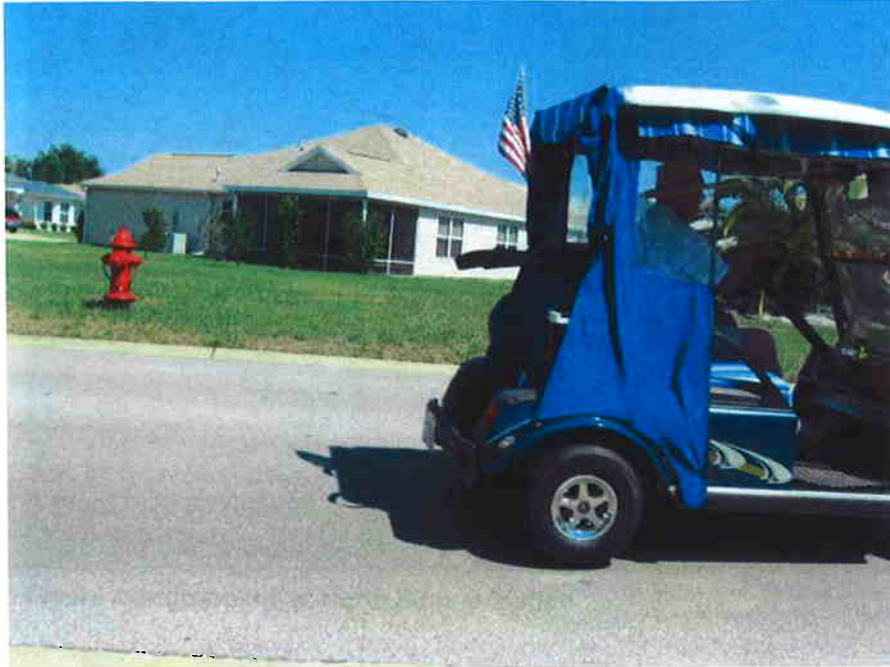
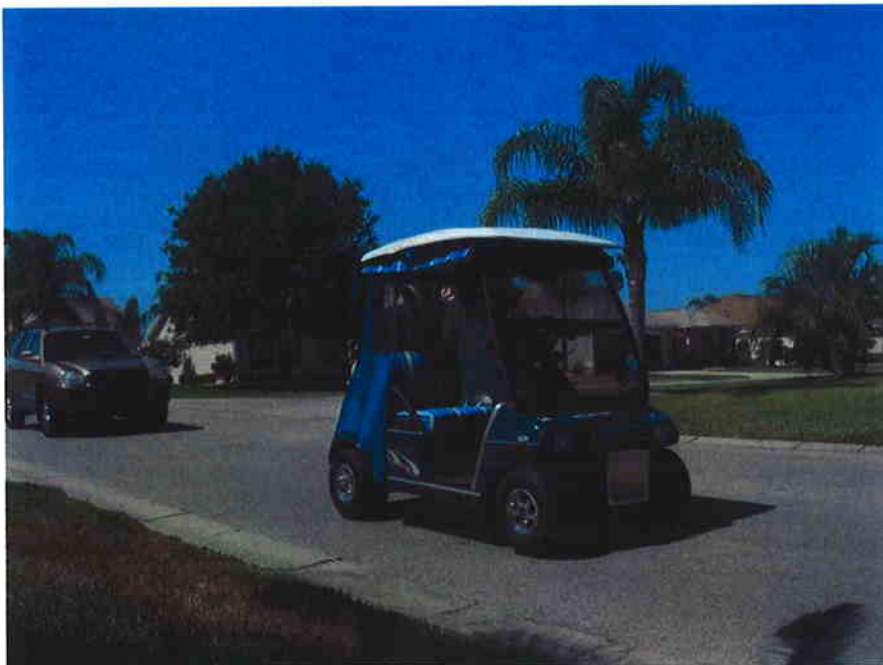
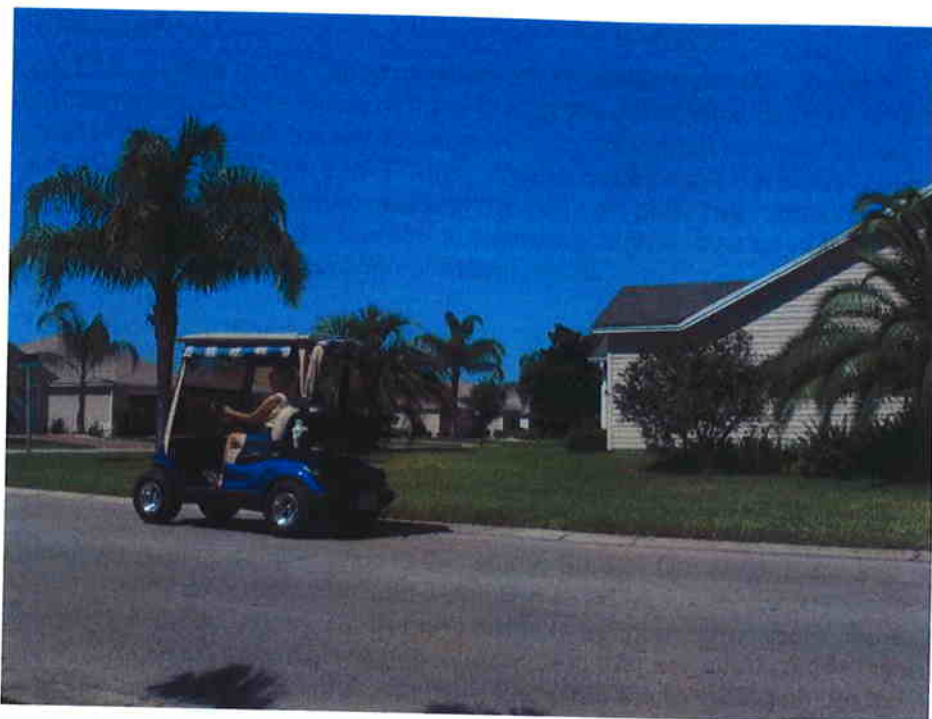
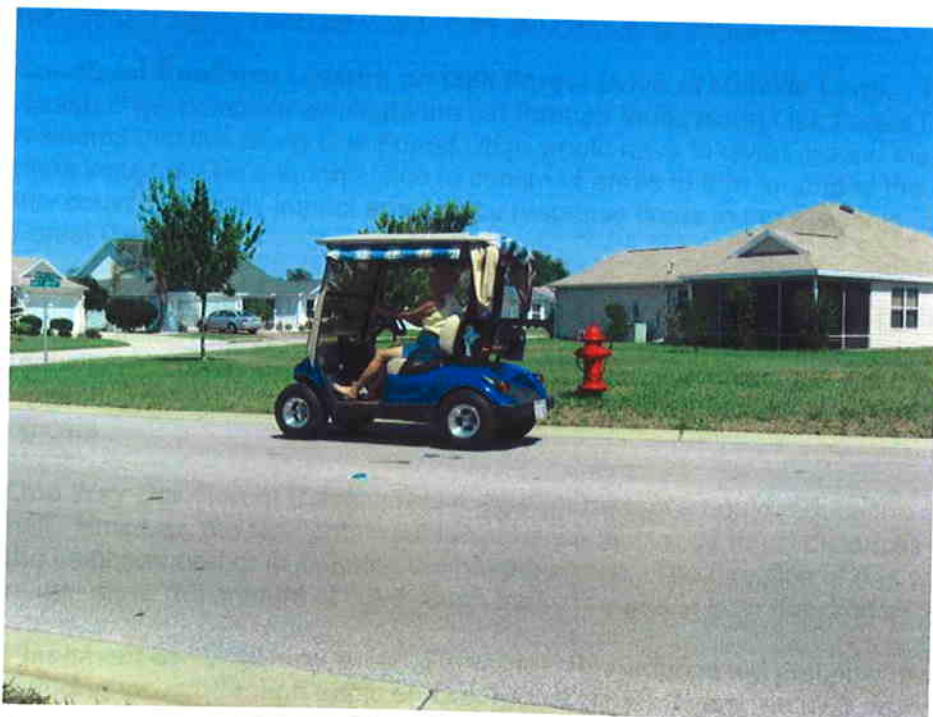
The photographs taken at the north survey station were compared to the photographs taken at the south survey station to identify vehicles that traveled through both survey stations. The vehicles that traveled through both survey stations are the vehicles that are using Oak Forest Boulevard as a cut-through route. A sample of the comparison photos are shown in Figures 2 through 5.

Figure 2 Northbound at South Survey Station

Figure 3 Northbound at North Survey Station

Figure 4 Southbound at North Survey Station

Figure 5 Southbound at South Survey Station

The results of the photo comparison indicated that 114 vehicles northbound and 114 vehicles southbound during the study period were utilizing Oak Forest Boulevard as a cut-through route which equates to approximately 60% of the traffic on Oak Forest Boulevard is cut-through traffic.
